SITE

The tile contains five principal house-like volumes beside a paved road running from the west edge towards the south edge. Four houses occupy its northeastern side with front courts, an enclosed garden and associated roofed structures; House 5 stands separately in an open vegetated plot to the southwest. A six-bay greenhouse block occupies much of the northeastern tile, with additional tunnel fragments along the north and east edges and a work yard containing stored materials and vehicle/equipment envelopes. Driveway and dirt/service runs supplement the through road; their mapped extents do not establish legal access, and the R07 service alignment requires verification.

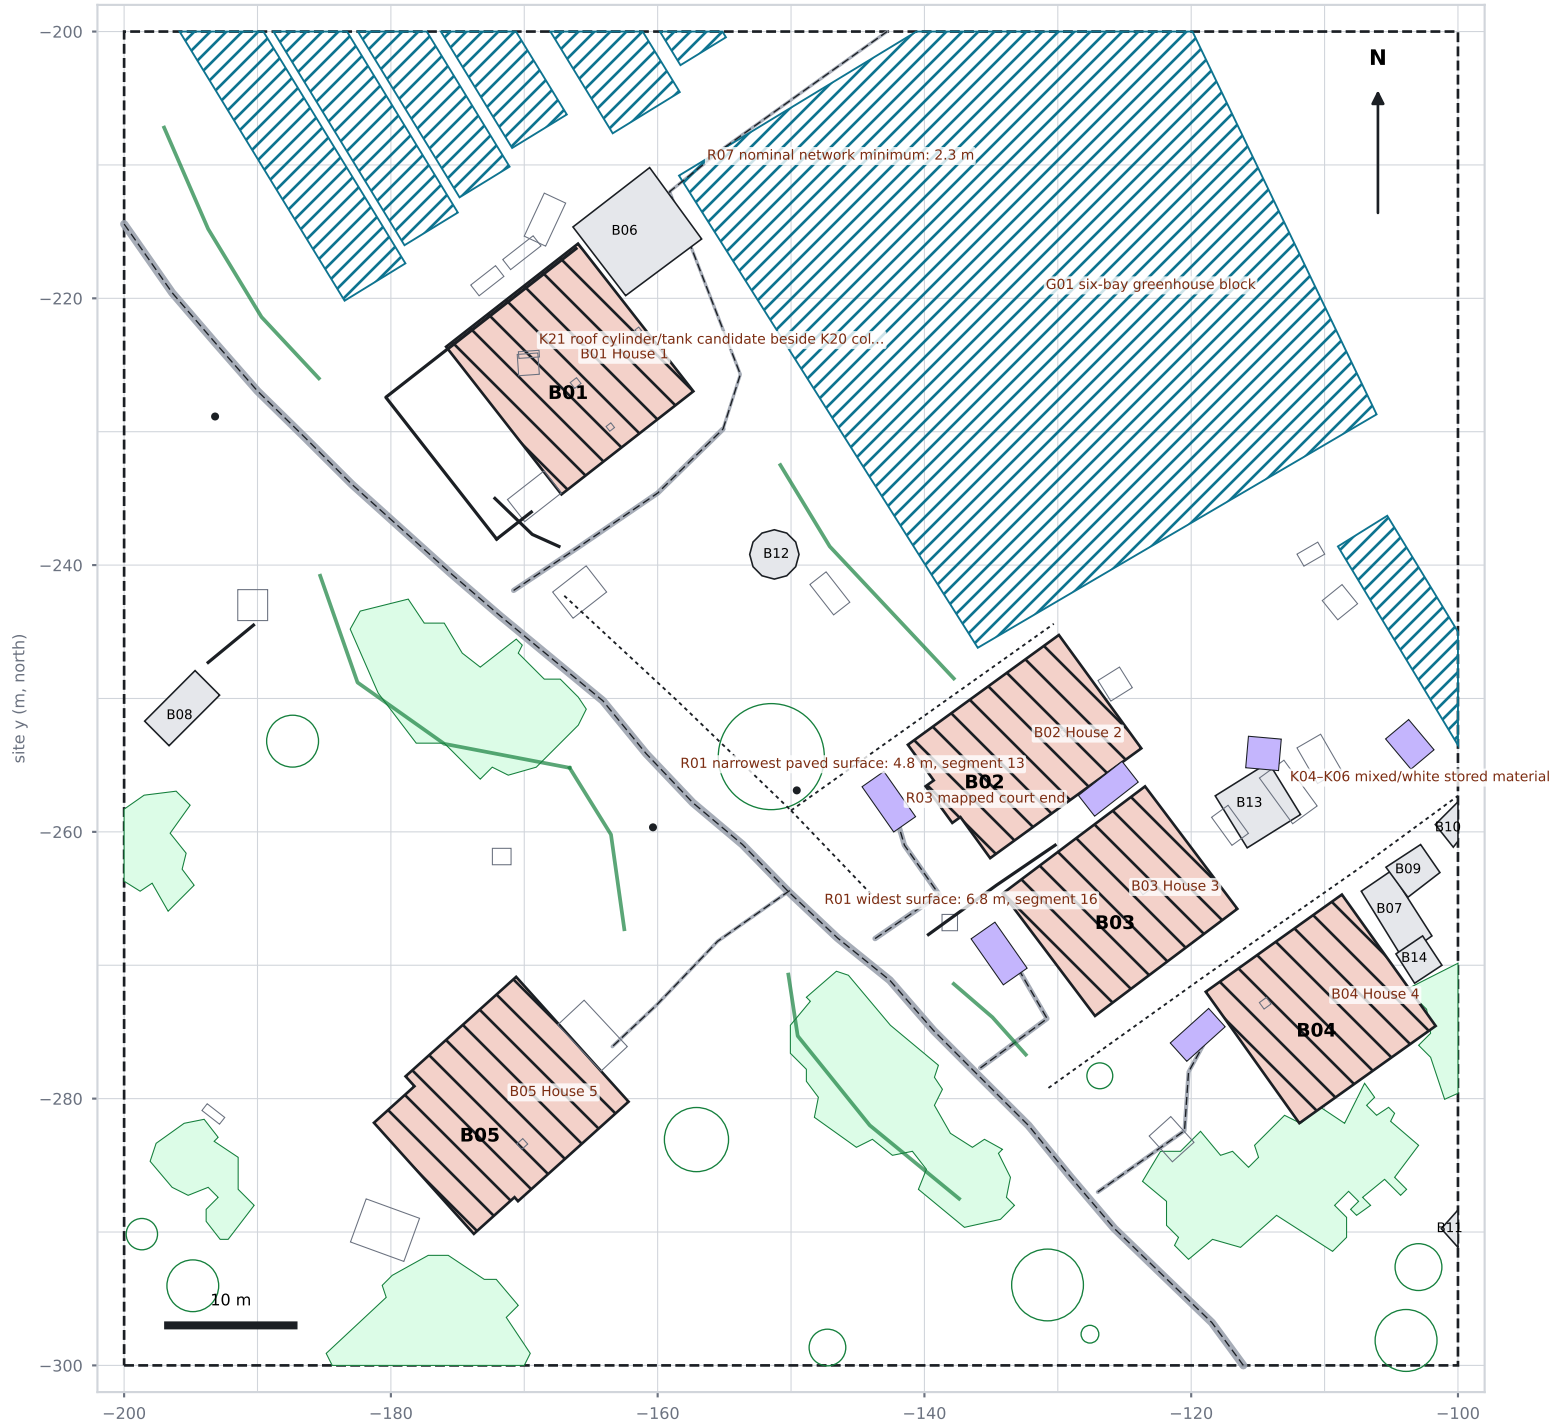
A red tile-like gable, roof-mounted collector/cylinder and the linked low sheet-roof annex B06 are visible. The inventory confirms one N-side and one S-side window; W-side steps K09 do not establish a doorway, and no door is securely observed. The scheduled setback is to R07 segment 1, not the paved through road, and the nearest building is the linked annex B06. F01 courtyard-wall and R07 service-route discrepancies reduce confidence in the surrounding site geometry; supplied geometry is retained pending verification. Sides not seen: None wholly unseen; all four facades incomplete..

The red tile-like roof has intersecting pitched forms and a road-facing dormer/projection, consistent with the complex-roof inventory. Four N-side windows are inventoried; the W-side entrance candidate remains unclassified and is excluded from the door count. The setback is to terminal courtyard approach R03 segment 3; parked V01 affects this approach, and the S facade is insufficiently observed. Sides not seen: S — unseen or insufficient for opening assessment..

The red tile-like roof has a road-facing dormer/projection and roof-space volume visible in the obliques. Two W-side windows and one E-side window are inventoried; the W-side entrance candidate is not a confirmed door. The setback is to R04 segment 2 near its mapped termination and parked V02; the S facade and roof-space occupancy are not verifiable. Sides not seen: S — unseen or insufficient for opening assessment..

The gabled tile-like roof shows pronounced grey/brown and red colour variation, warranting closer inspection rather than a defect classification. The inventory links tiled B07, sheet-roofed B09 and B14, and tile-edge fragment B10 through this annex group; B10 is separated from its recorded parent B09 by 1.8 m, so physical attachment is not established. One W-side window and one W-side ground-reaching aperture are recorded, but the aperture is not classified as a door. The setback is to R05 segment 3; the nearest-building gap is to linked annex B14, while E and S facade coverage remains insufficient. Sides not seen: E and S — unseen or insufficient for opening assessment..

The orange-red tile-like roof has intersecting hipped forms over the stepped footprint. Semicircular E-side steps K10 are visible, but the adjacent no-return bay is not a confirmed opening; no windows or doors are securely inventoried. The setback is to the mapped end of dirt track R06 segment 3, not the paved road, and incomplete facades, particularly S, prevent an opening or occupancy survey. Sides not seen: S — unseen or insufficient for opening assessment..
